UNDERWATER BRIDGE INSPECTION REPORT

STRUCTURE NO. 66511

CANNON RIVER

DISTRICT 6 - RICE COUNTY

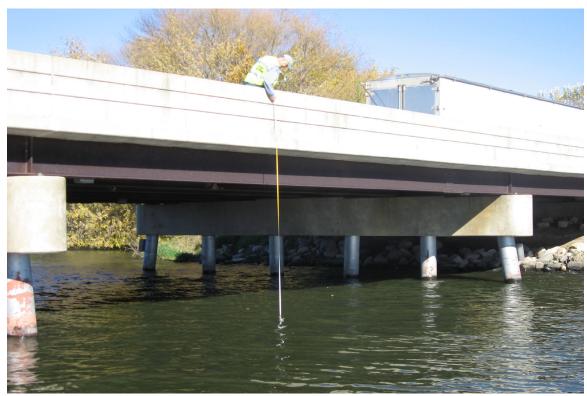
Photograph 1. View of Pier 1, Looking North.

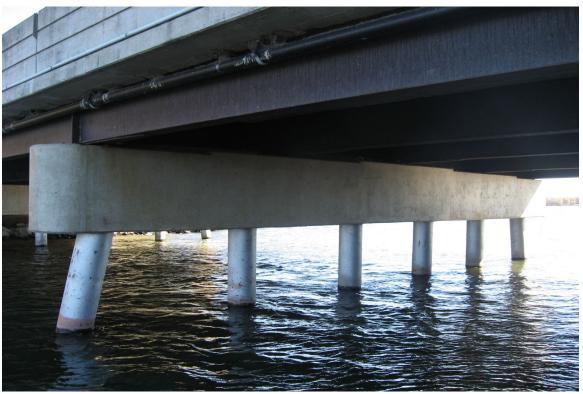
Photograph 2. View of Pier 2, Looking North.

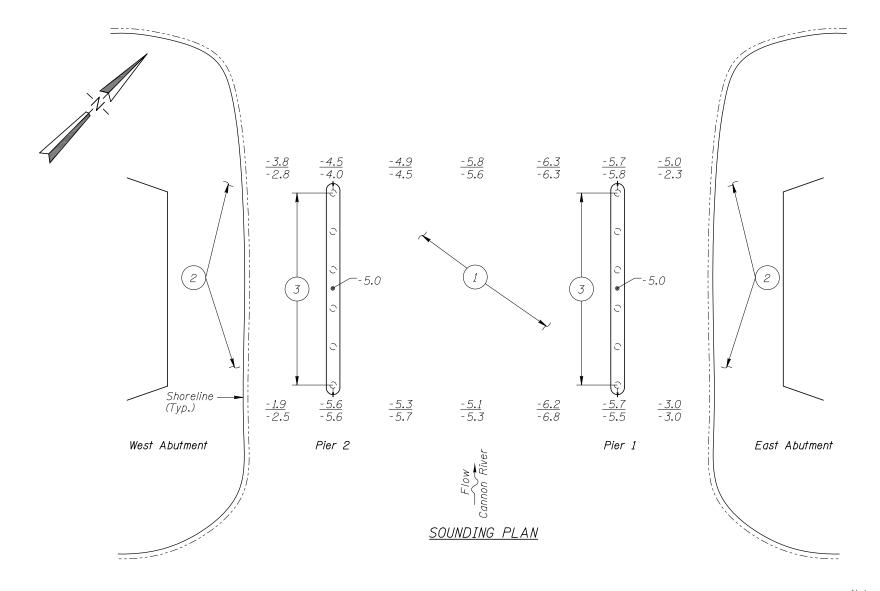
INSPECTION AND SOUNDING PLAN

- (1) The channel bottom material consisted of gravel with cobbles and riprap, 2 foot diameter and smaller, with no probe rod penetration possible.
- (2) Riprap, 4 feet diameter and smaller, serves as a protective barrier between the abutment and channel.
- 23 Light to moderate corrosion on the steel casings from the channel bottom to 6 inches above the waterline, slightly heavier near the waterline with 1/4 inch nodules. No noticeable loss of section. Coating failure on all piles 50 to 100% and 100% around the waterline. The concrete caps are in good, sound condition.
